# Inspection Report

**Property Address:**  
123 Main Street  
Anytown IL 60000

**Fine Home Inspection**

<b>Date:</b> 4/11/2013	<b>Time:</b> 08:30 AM	<b>Report ID:</b> 0411201301
<b>Property:</b> 123 Main Street Anytown IL 60000	<b>Customer:</b> Any Name	<b>Real Estate Professional:</b>

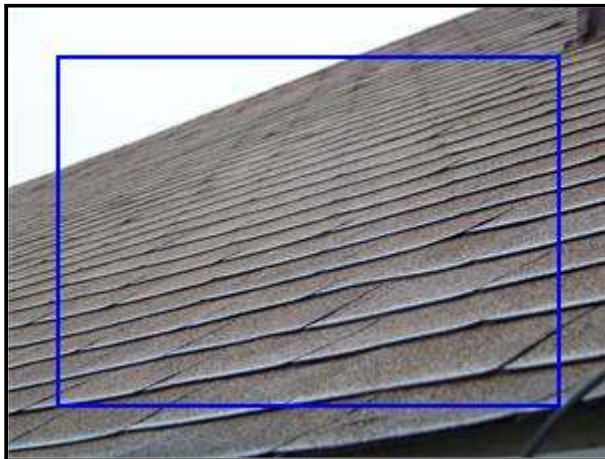
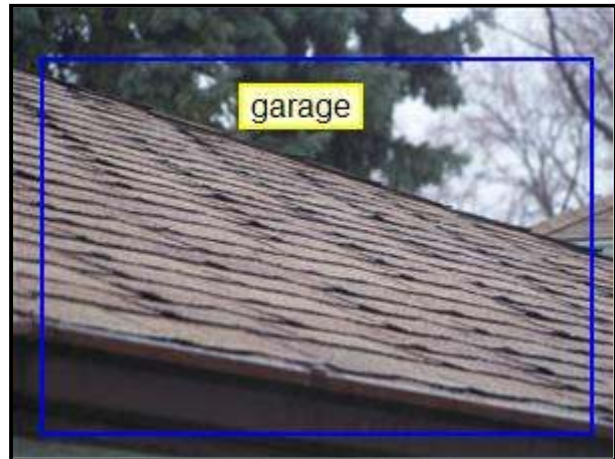
The roof covering is nearing the end of its life cycle at the "entire roof". Recommend on budget for a roof replacement in the next 5 years. A qualified contractor should inspect and repair as needed.

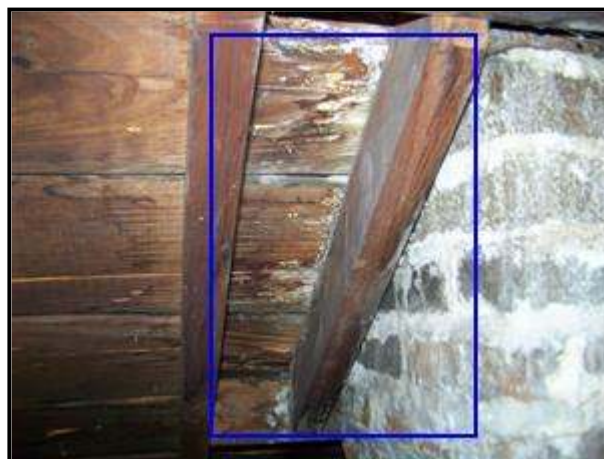
E. Picture 1

(1) The roof sheathing is somewhat deteriorated or soft at the chimney. The leak appears corrected. It is not cost effective to perform repairs until the next roof. Maintenance caulking at chimney flashing will be needed periodically.

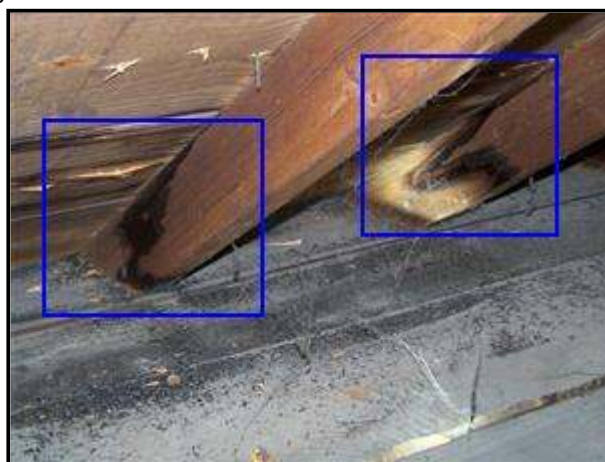
E. Picture 2

(2) Stains on the roof trusses observed in attic. Tested with moisture meter for possible moisture -dry at inspection time. This is for your information.

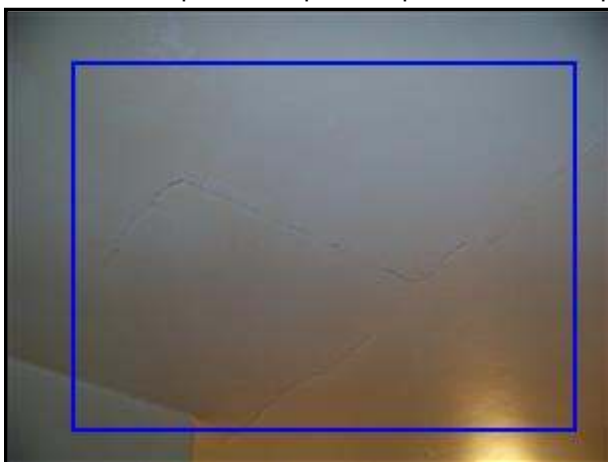
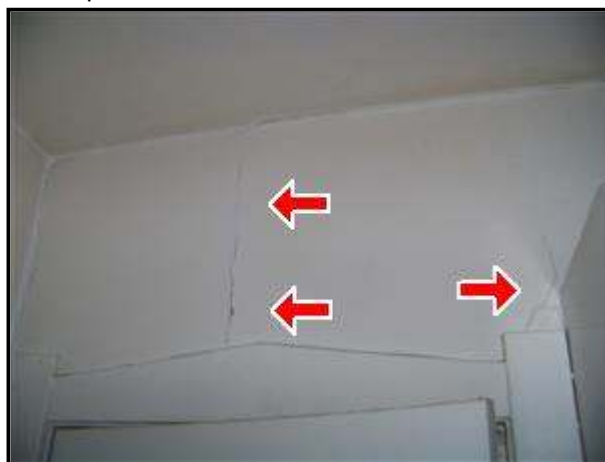
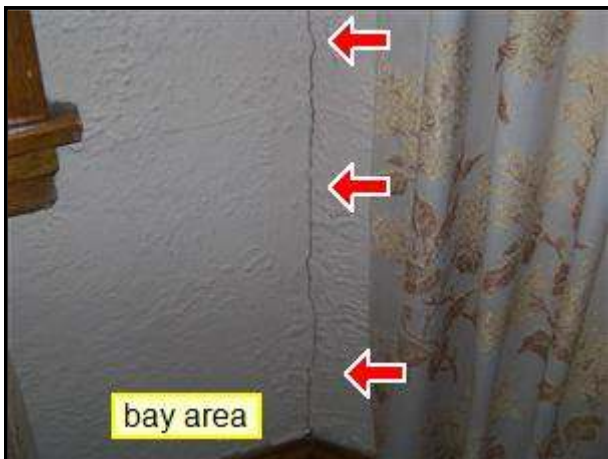
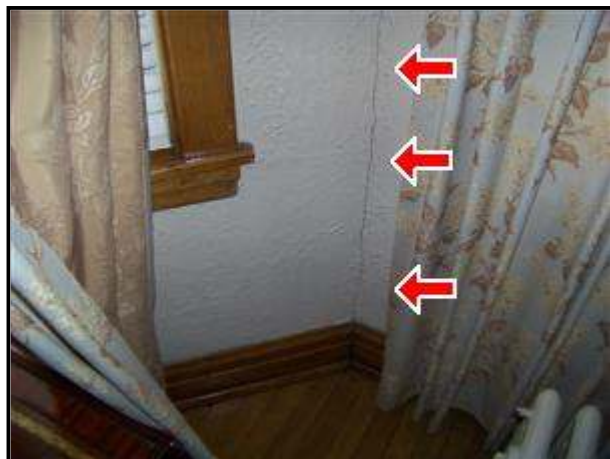
(1) The plaster on the wall and ceiling has several cracks throughout home. While this damage is cosmetic, it needs to be repaired. A qualified person should repair or replace as needed.

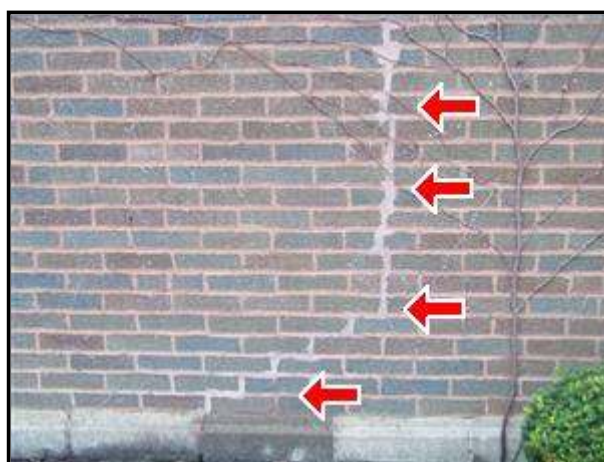
F. Picture 5

(2) Visual repair to the exterior wall (north side). No apparent problem was found. This is for your information.

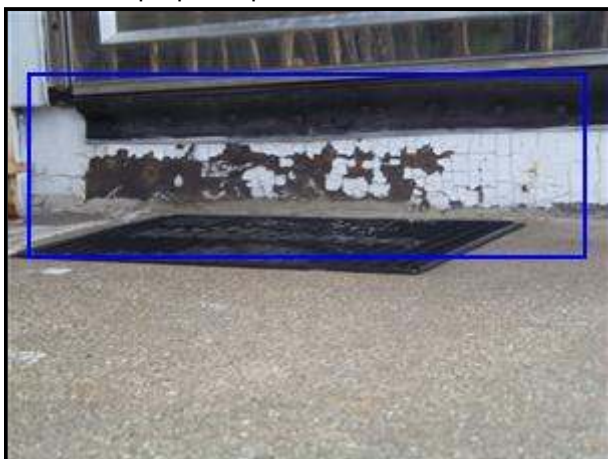
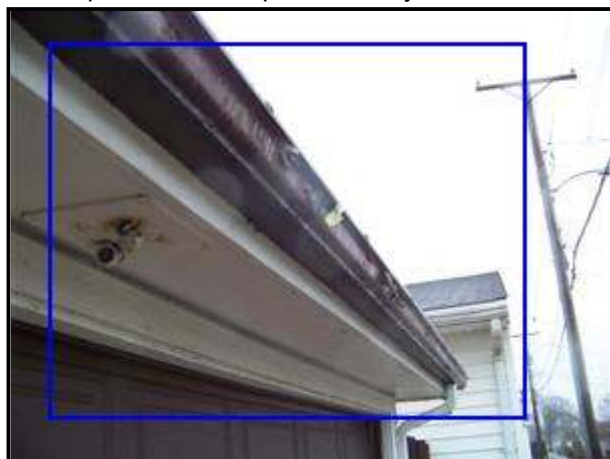
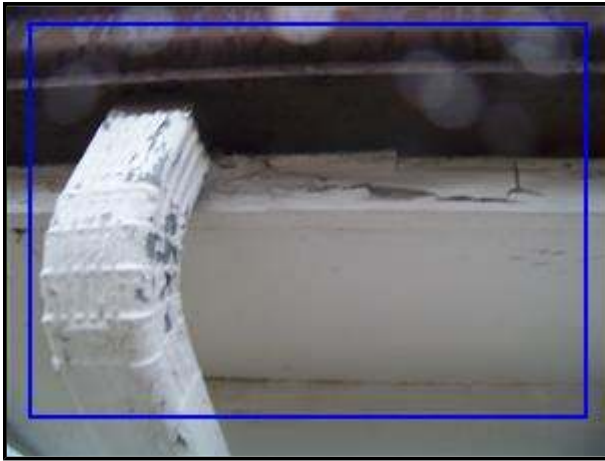
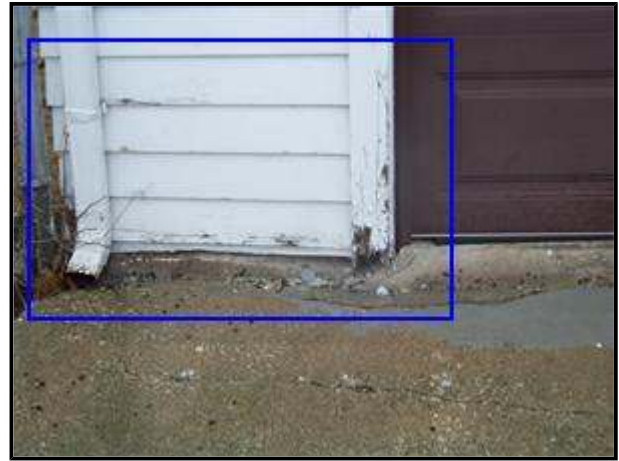
(3) The paint on eave, fascia and door/window trim is failing. Some rooted wood need to be replaced. I recommend prep and paint at the exterior in areas. Qualified person should perform the job.

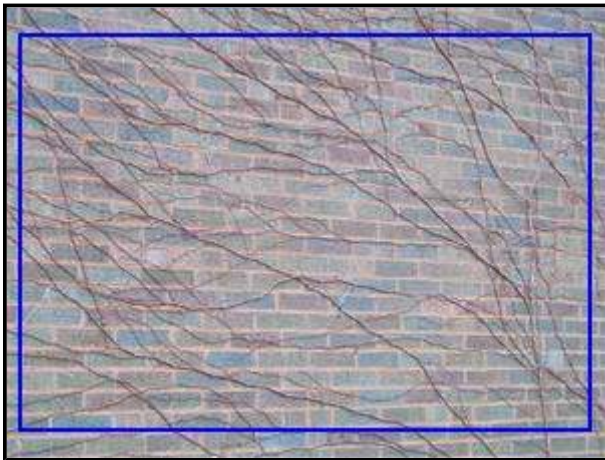
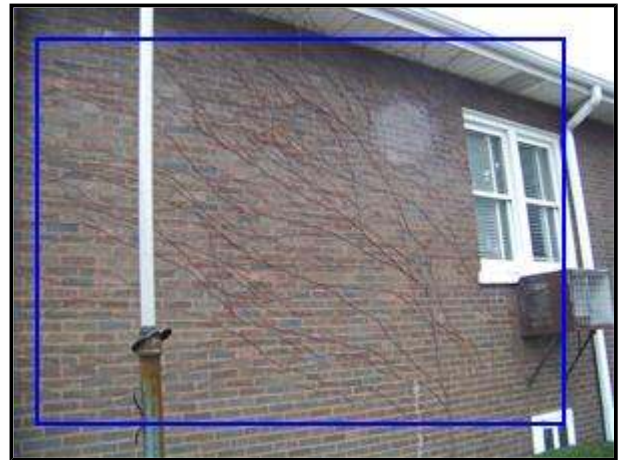
(4) Vines on the wall (north side of home) should be removed to prevent damage to the mortar. Qualified person should perform the job.

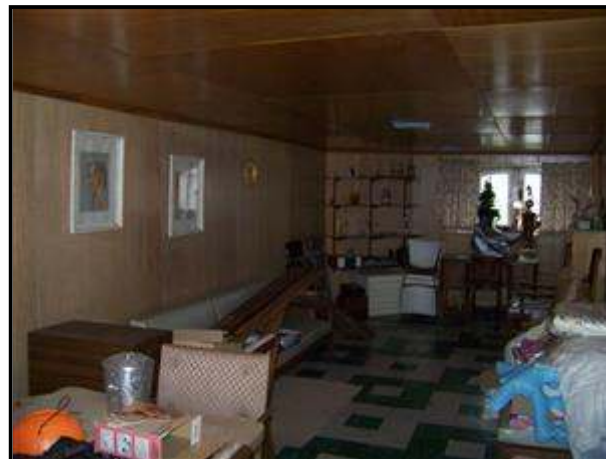
F. Picture 12

(5) Most of the walls and ceilings in the finished basement are covered and structural members are not visible. No obvious problems discovered. I could not see behind these coverings.

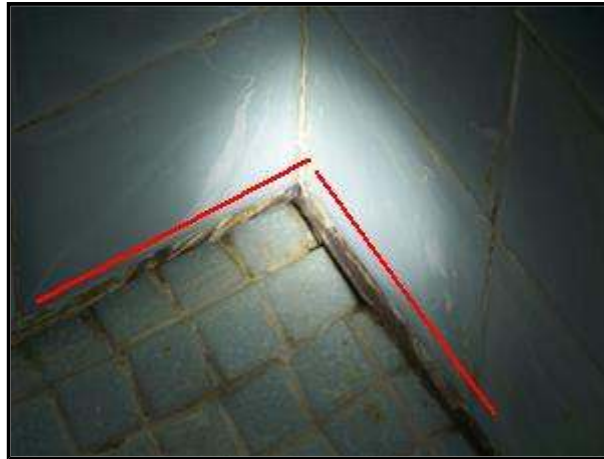
F. Picture 13

(6) The Tile surround at shower on the wall missing silicone caulk at inside corners and at shower pan (floor) perimeter, also tile is peeling in areas. Water is entering behind covering and needs correcting at the lower level bath. A qualified person should repair or replace as needed.

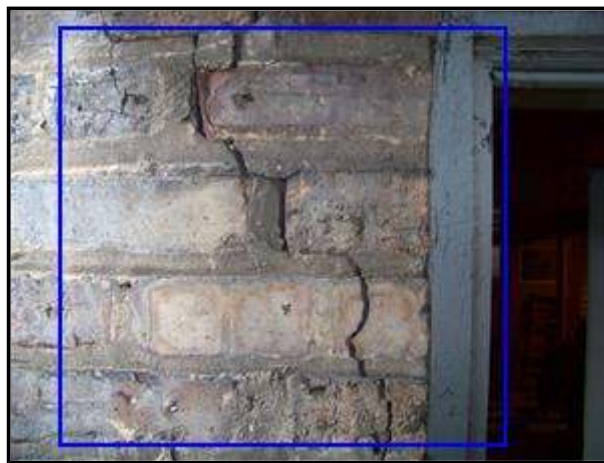
F. Picture 14

(7) Cracked brick wall next to basement entry. Repairs are needed. Qualified person should perform the job.

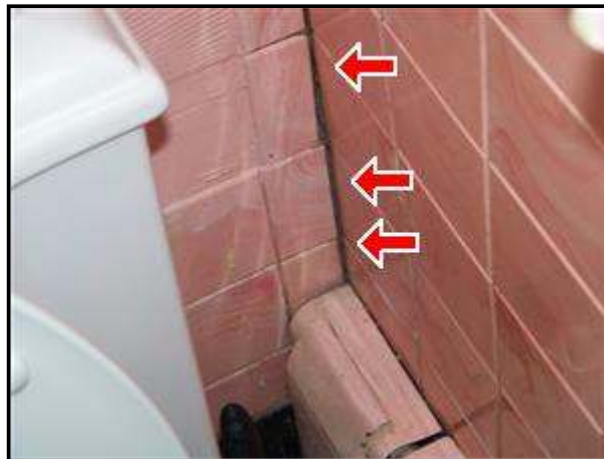
F. Picture 15

(8) Separation on the wall at the main floor bathroom should be repaired using qualified person.

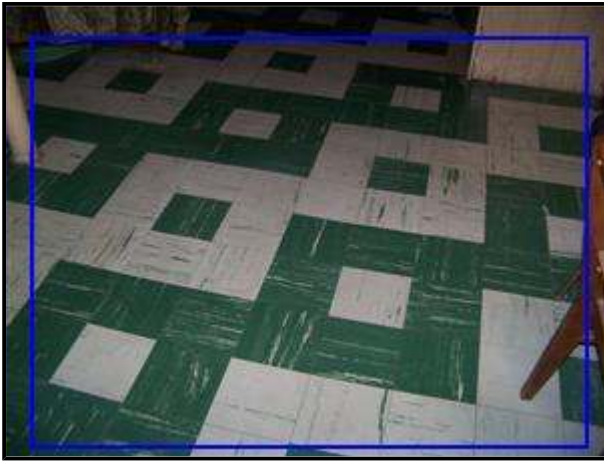
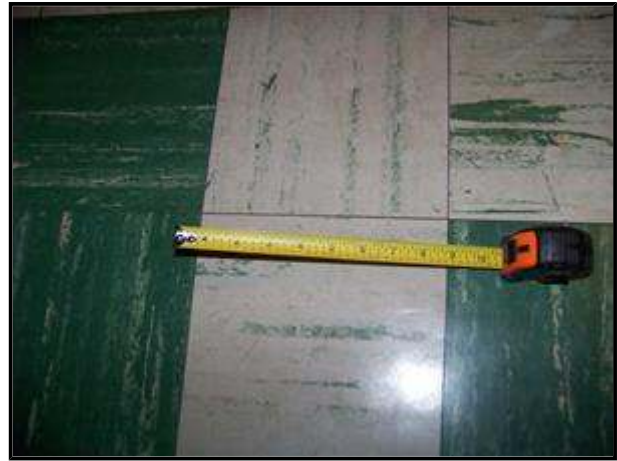
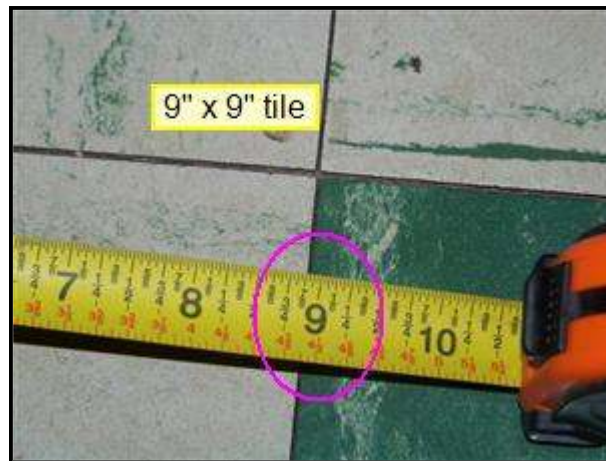
(1) Possible asbestos floor tile in basement. Recommended contact a licensed asbestos inspector. This professional will perform a thorough inspection to determine the location of all asbestos-containing materials, as well as offer advice about abatement procedures and how the asbestos materials should be removed or contained.

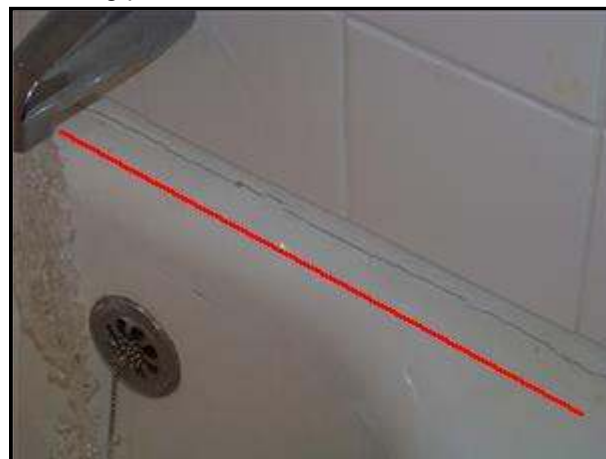
G. Picture 4

(2) I recommend silicone caulk along perimeter of tub and wall surround at main bath.

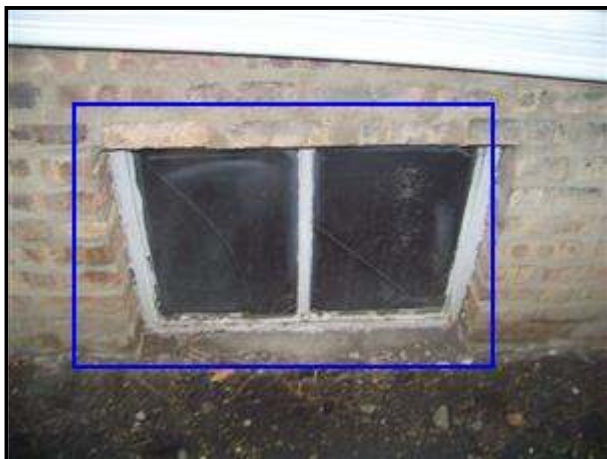
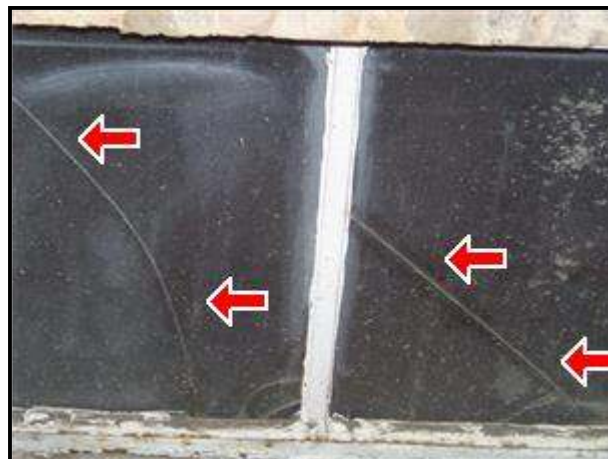
Two windows cracked at glass pane at the Utility room. Cracked glass should be replaced to prevent injury or damage. A qualified person should repair or replace as needed.

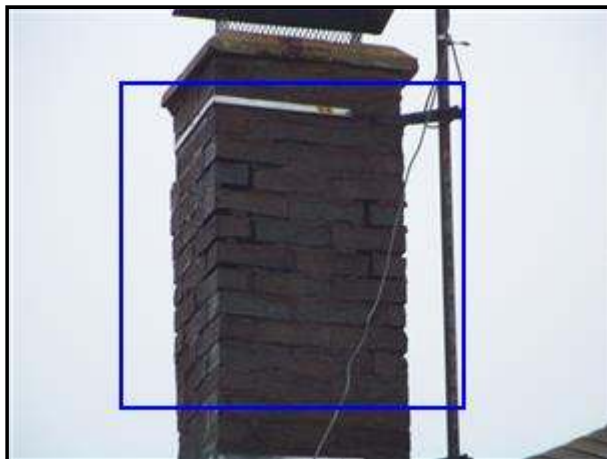
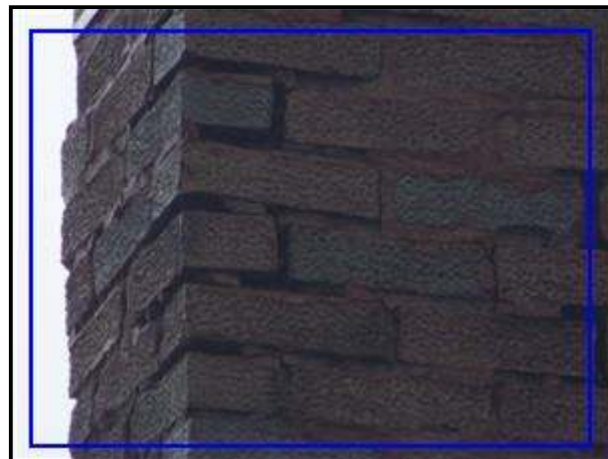
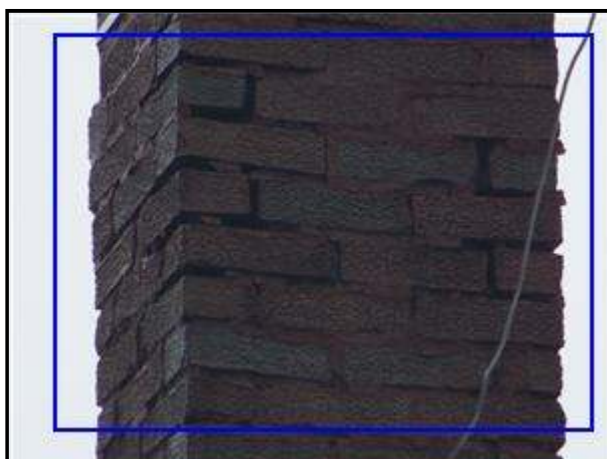
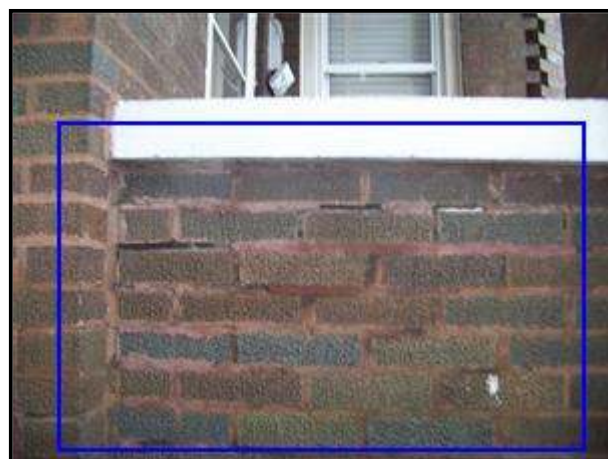
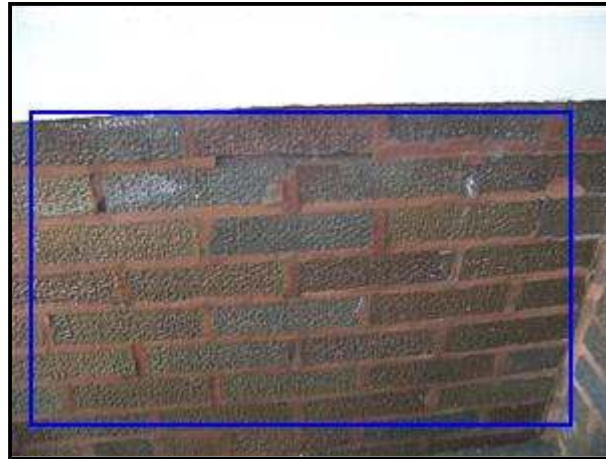
(1) Tuck pointing is needed at the chimney and exterior walls in areas. Qualified contractor should perform the job.

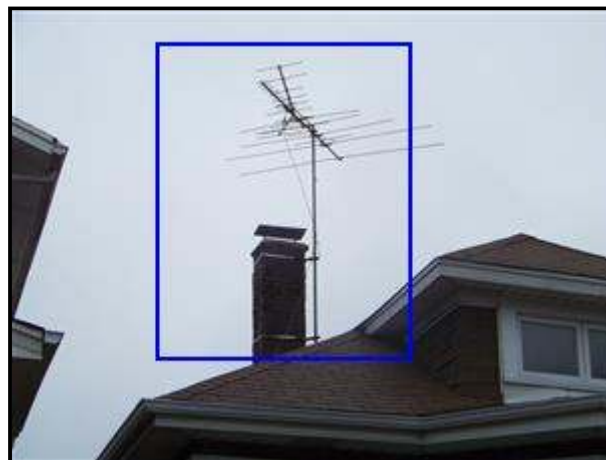
J. Picture 6

(2) TV antenna should be removed from chimney to increase stability to the structure. Qualified person should complete the job.

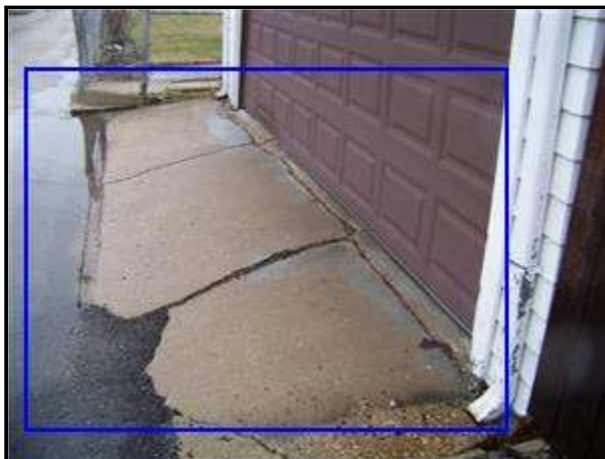
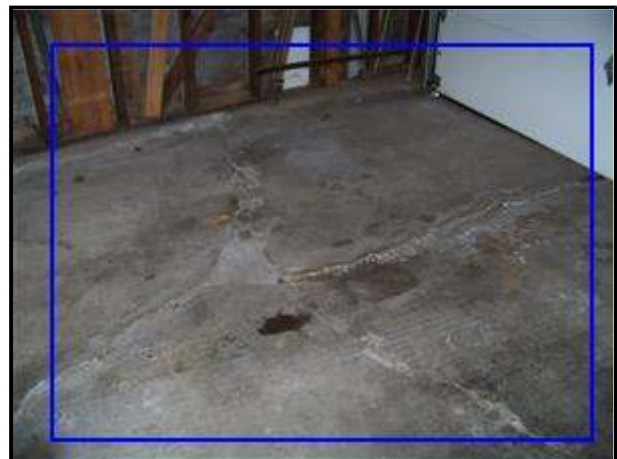
The concrete floor of garage and driveway is cracked and damaged in areas. Potential trip and fall hazard due to uneven cracks in the surface. Further settlement may occur. Recommended qualified contractor to inspect future and repair as needed.

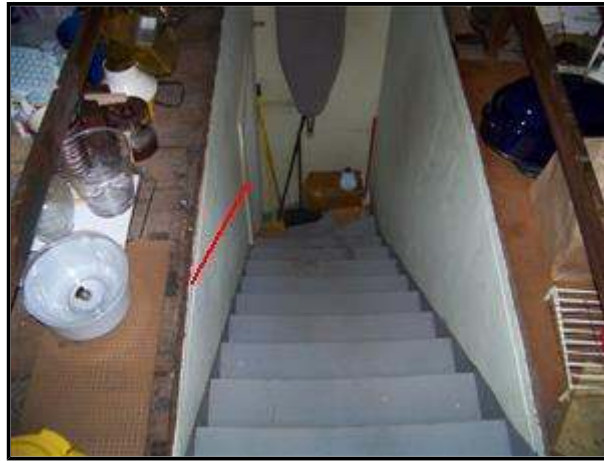
L. Picture 1

(1) The hand/guard rail for the attic stairs is missing also baluster in the attic should be installed. A fall or injury could occur if not corrected. A handrail and baluster should be installed for safety A qualified contractor should perform the work.

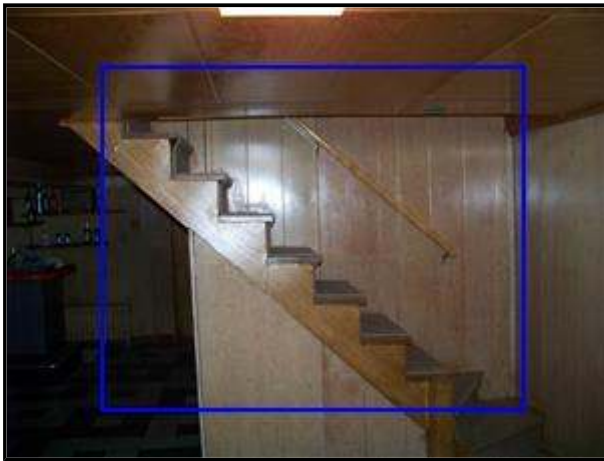
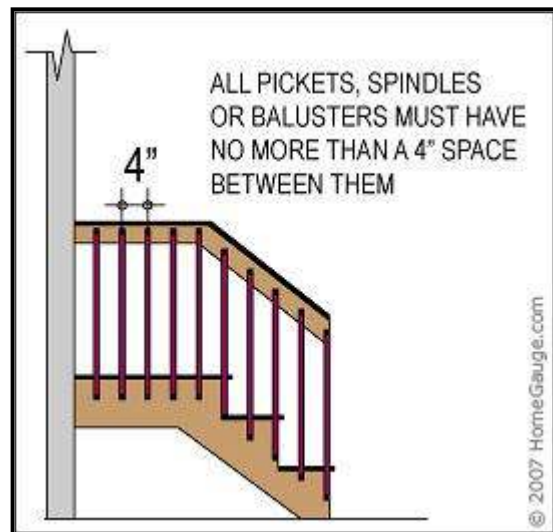
(2) The stairs to basement does not have a guard rail with proper picket spacing. Spacing more than 4 inches apart could allow an adult, child or pet to fall through. A qualified contractor should inspect and repair as needed.

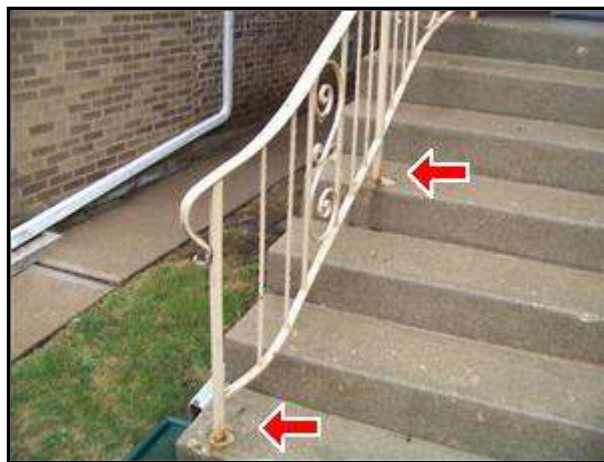
L. Picture 4

(3) The balusters on the guard rail at the front entry are rusted and shows paint failing or peeling. Further deterioration can occur if not prepped and sealed or painted. A qualified person should repair or replace as needed.

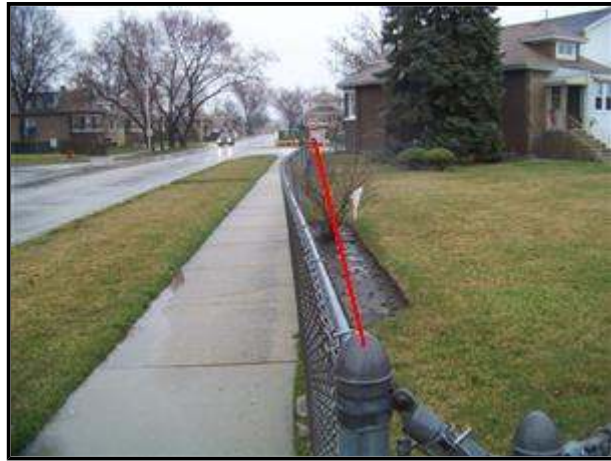
L. Picture 5

(4) Fence is old and unstable, damaged in areas, repairs are needed using qualified contractor.

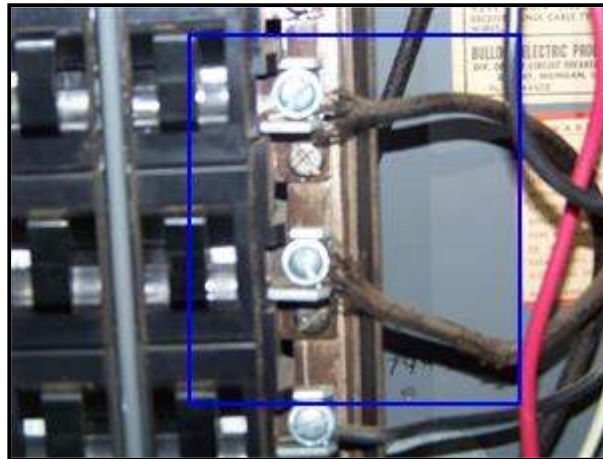
B. Picture 1

(1) Aluminum wire is installed on 120 VAC branch electrical circuits in the subject house. These single strand, branch circuit aluminum wires were used widely in houses during the mid 1960s and 1970s. According to the U.S. Consumer Product Safety Commission, problems due to expansion can cause overheating at connections between the wire and devices (switches and outlets) or at splices, which has resulted in fires. For further information on aluminum wiring contact the U.S. Consumer Product Safety Commission via the Internet at <http://www.cpsc.gov/> . It is recommended that the electrical system be evaluated by a licensed electrical contractor.

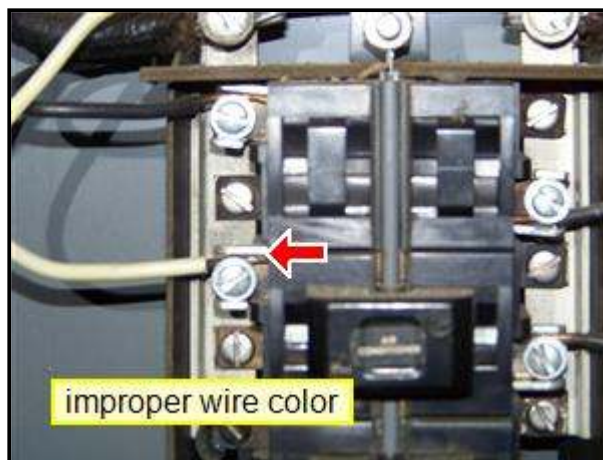
B. Picture 2

(2) Problem(s) discovered with Branch Circuits such as aluminum branch wiring, improper wiring (with wire connected to a breaker), and any other problems that an electrical contractor may discover while performing repairs need correcting. I recommend a licensed electrical contractor inspect further and correct as needed.

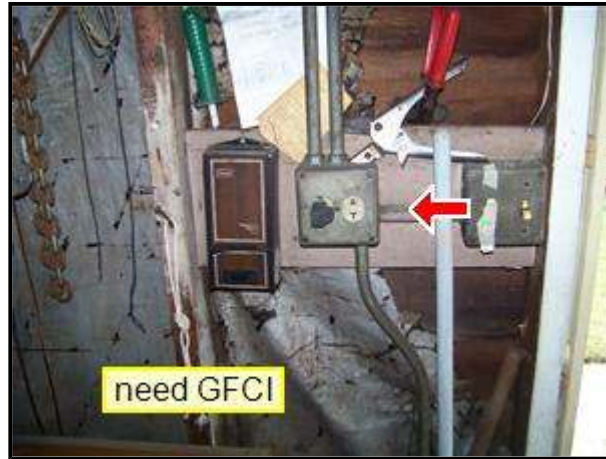
B. Picture 3

(3) "three-prong" outlets are outdated and not a three-prong GFCI (Ground Fault Circuit Interrupt) in the garage. This is a safety issue that needs to be corrected. A qualified licensed electrical contractor should perform repairs that involve wiring.

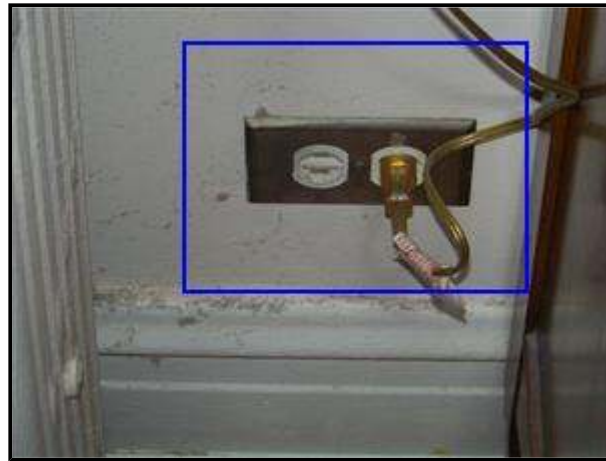
B. Picture 4

(4) "two-prong" outlets are outdated and not a three-prong outlets in most if not all rooms. Electrical issues are considered a hazard until repaired. A qualified licensed electrical contractor should perform repairs that involve wiring.

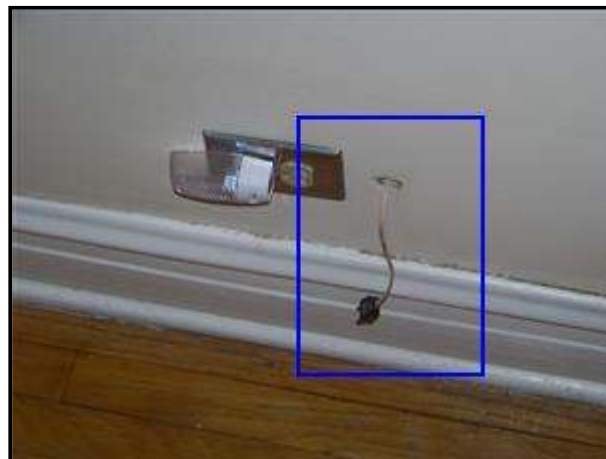
B. Picture 5

(5) The outside outlet is using an extension cord as permanent wiring, and needs to be properly wired or removed.

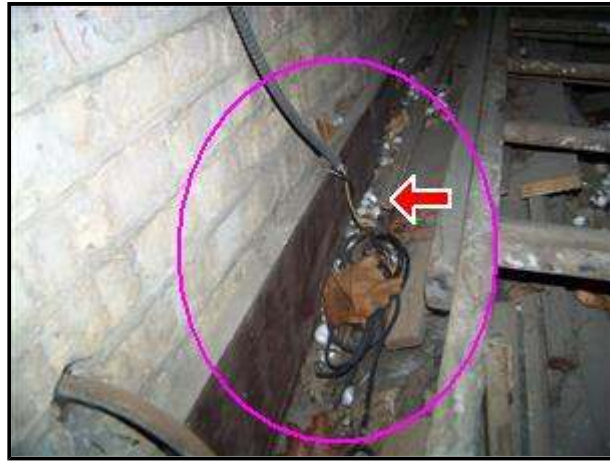
B. Picture 6

(6) Live loose wire found outside the home (below sun room) Wire should be properly secured if the purpose is exterior outlet should be GFCI with exterior cover or if purpose unknown wire should be removed. Licensed electrician should perform the job.

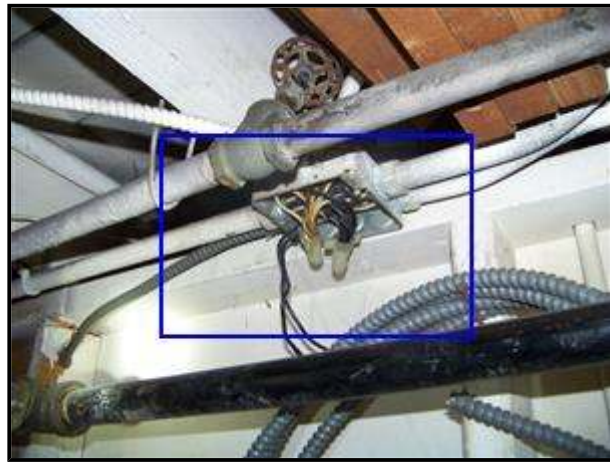
B. Picture 7

(7) junction box needs a cover-plate in the basement. I recommend repair as needed.

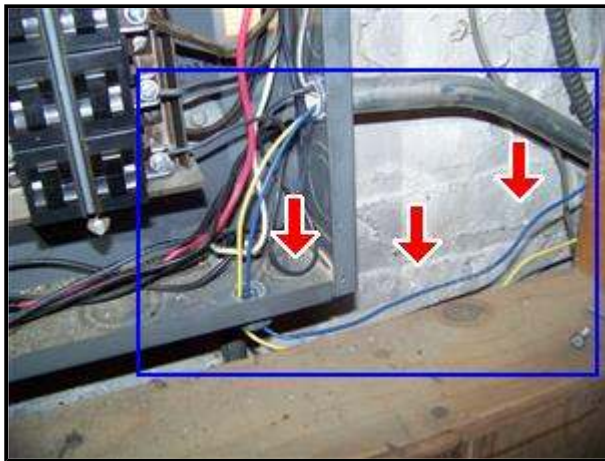
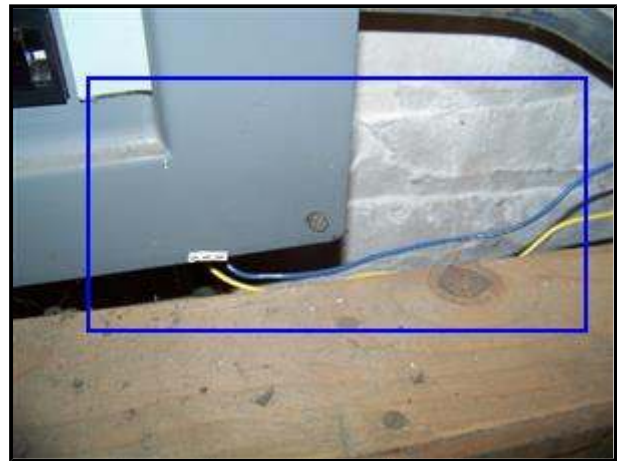
(8) Loose wires traveling through out the main electrical panel should be placed inside EMT pipe. Licensed electrician should perform the job.

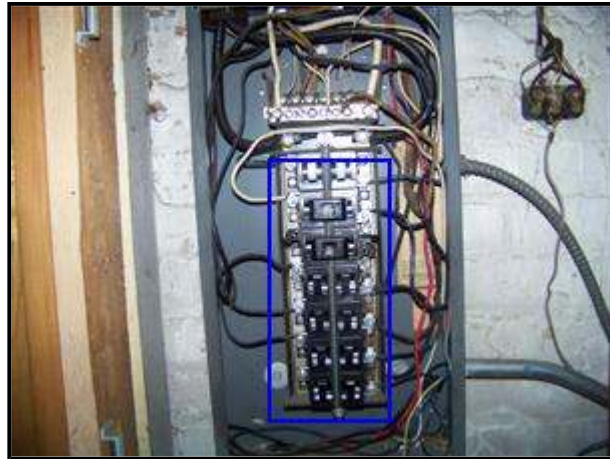
B. Picture 10

(9) Push-matic brakers found in main electrical panel. Recommended upgrade electrical panel to newer one. Licensed electrician should perform the job.

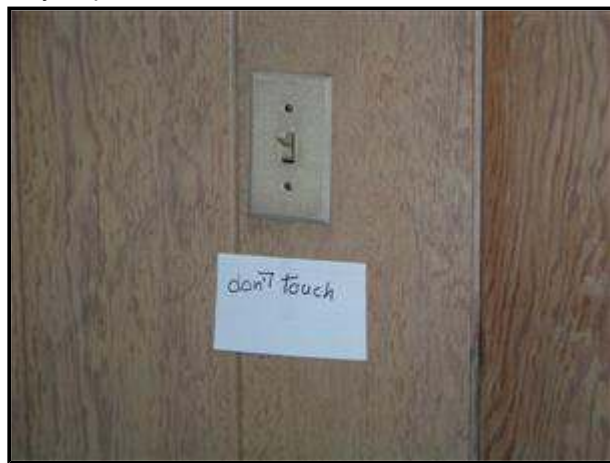
B. Picture 11

(10) The wall switch has note "do not touch" purpose is unknown (could not identify) at the basement. Further inspection is needed by a qualified licensed electrical contractor.

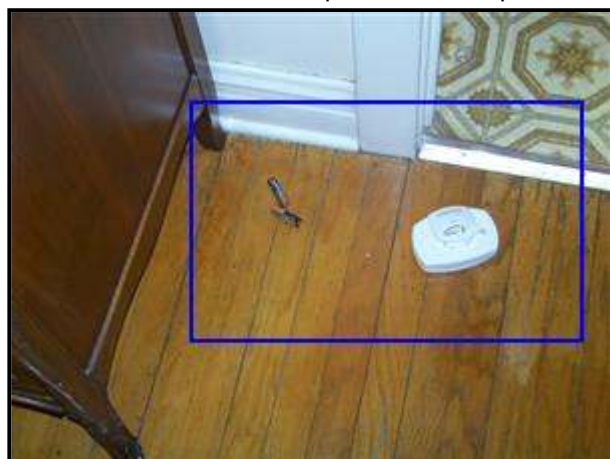
C. Picture 1

The smoke detector has been disconnected intentionally at the bedroom. Without a working smoke detector in your home you have no first alert to a possible fire. It is recommended that one be installed according to the manufacturer's instructions. Qualified person should perform the job.

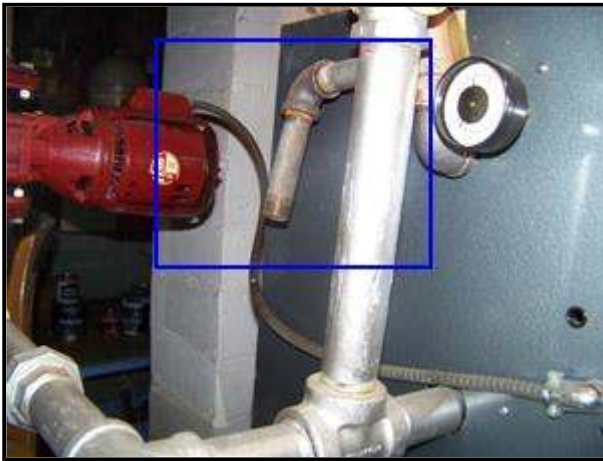
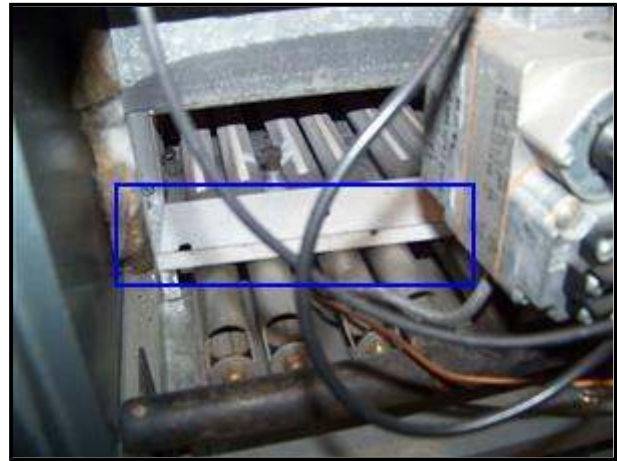
The T&P (Test and Pressure) valve on boiler needs a 3/4 threaded pipe to extend within 6 inches of floor for safety. (PVC is not approved for hot water use). Also safety door should be properly installed. I recommend repair by a qualified person.

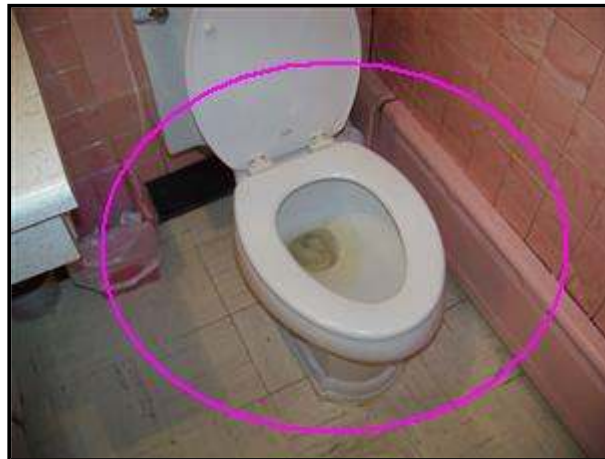
A. Picture 1

The toilet is loose at floor at the bath. Repairs may involve re-setting the toilet on a new wax seal. I recommend a qualified licensed plumber repair or correct as needed.

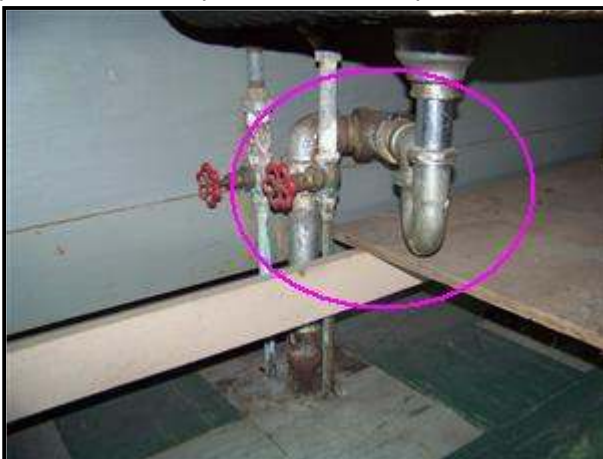
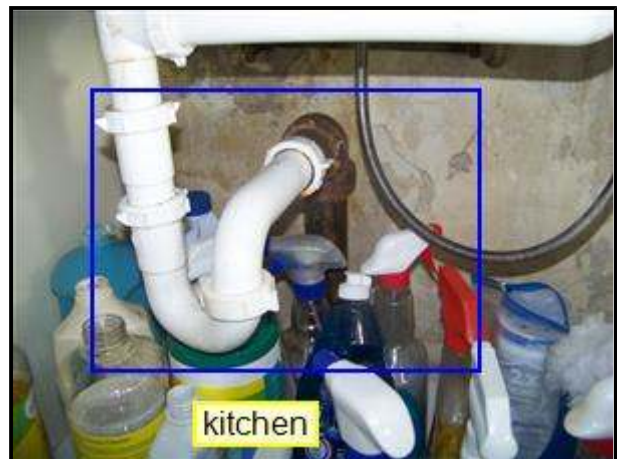
The plumbing waste line is a S trap and needs upgrade to a P trap with an auto-vent in the basement and under the kitchen sink. A s-trap can sometimes gurgle (struggling for air when draining water), or if not used for long periods can evaporate the water in the trap and cause sewer odors to leak out. A s-trap can sometimes lose the water in the trap through a pressure drop in the sewage system (outside the house). A qualified licensed plumber should repair or correct as needed.

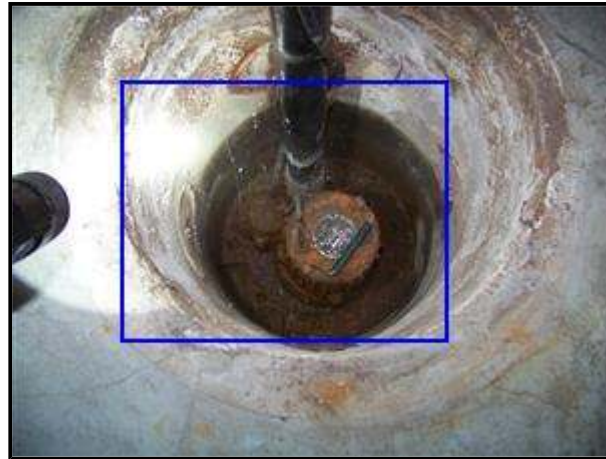
D. Picture 1

(1) Sump pump is rusted and replacement is needed. Qualified person should perform the job.

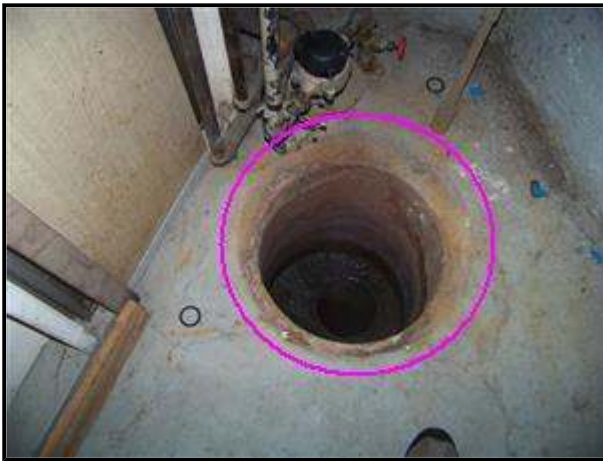
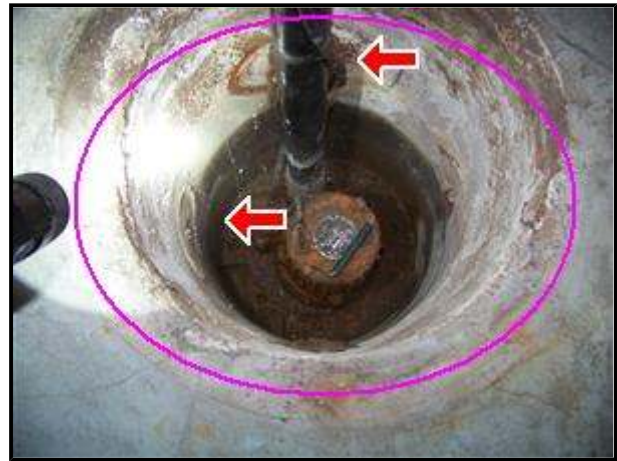
(2) The container for sump pump does not work or is non-functional (heavy rain before inspection). This installation does not appear adequate (no visual drain tile). I recommend further investigation or correction by a qualified licensed contractor or water infiltration specialist.

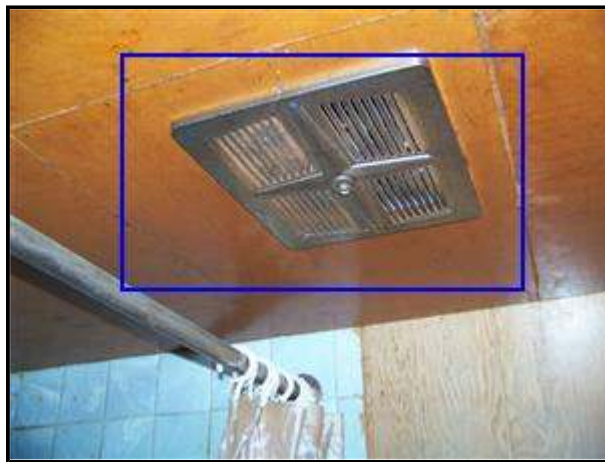
G. Picture 1

The Exhaust fan is noisy at the lower level bath. A qualified person should repair or replace as needed.

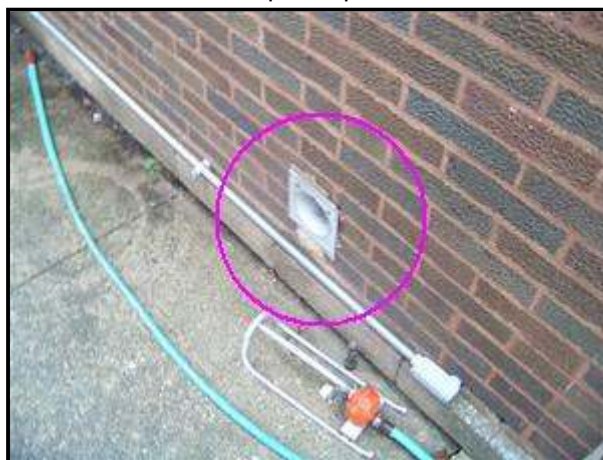
J. Picture 1

Dryer vent is damaged outside. Recommended repair/replace as needed.
